# Manhole Inspection Summary

Manhole # S33SS\_038MH

Insp Date: **4/19/07 11:20 AM**

**Location** Address: **2 26TH ST**

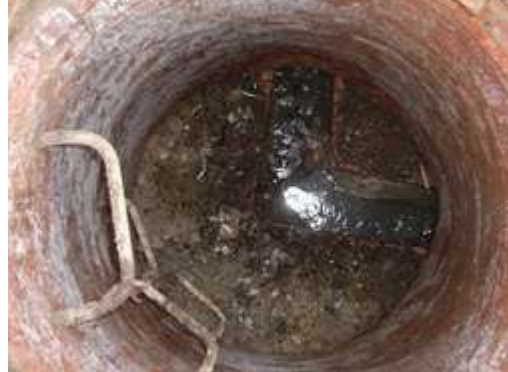
Top View

Corroded steps. Evidence of surcharge - Bench debris. Channel debris.

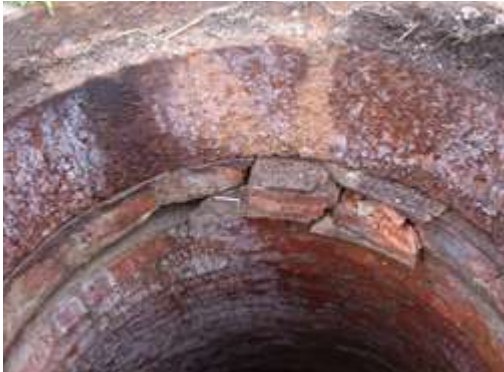
Defect

Adjustment deterioration, loose brick and infiltration. Corbel infiltration.

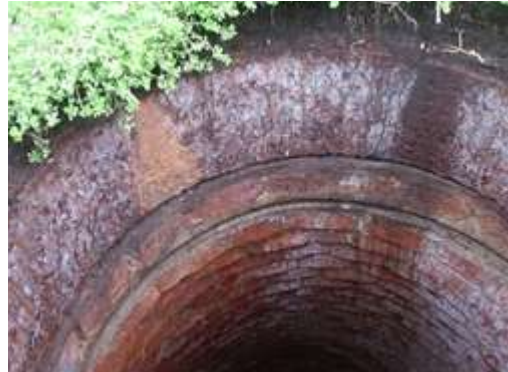
Defect

Adjustment deterioration and infiltration. Corbel infiltration.

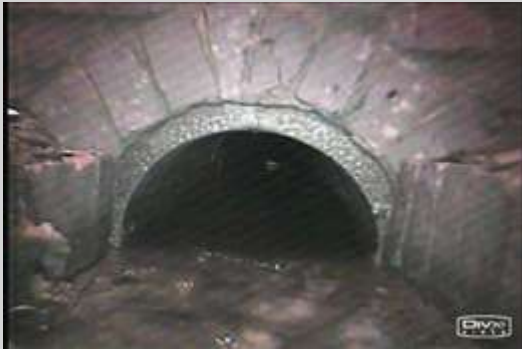
### 10 in. Circular Gravity Sewer Pipe Out @ 12 O'Clock

Deposits: ☐ None ☒ **Mud** ☐ Sludge ☒ **Debris** ☐ Grease

Silt Depth: **1** (in.) Deposits Extent: **Light**

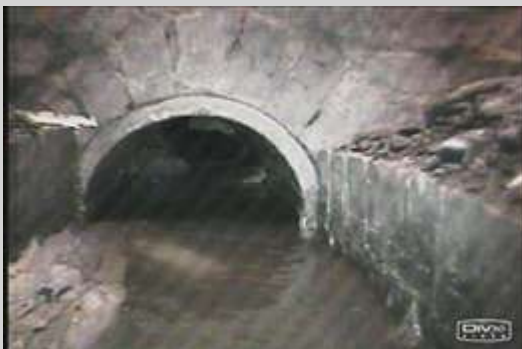
### 10 in. Circular Gravity Sewer Pipe In @ 3 O'Clock

Deposits: ☐ None ☒ **Mud** ☐ Sludge ☒ **Debris** ☐ Grease

Silt Depth: **1** (in.) Deposits Extent: **Light**
